Mobile Intel[®] Pentium[®] II Processor Specification Update

Release Date: November 2002

Order Number: 243887-046

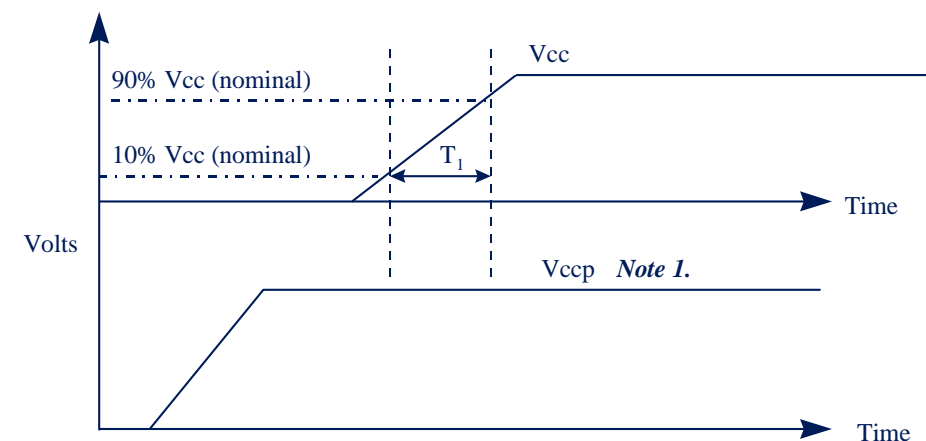
Figure 1. V_{CC}/V_{CCP} Timing Requirements (Mobile)

Problem: The processor uses the PWRGOOD signal to ensure that no voltage sequencing issues arise; no pin assertions should cause the processor to change its behavior until this signal is asserted, when all power supplies and clocks to the processor are valid and stable. However, if V_{CC} ramps up before V_{CCP} , it will cause the processor to enter an invalid state.

Implication: If this erratum occurs, the system may boot normally however, the L2 cache may not be initialized.

Workaround: For Mobile Pentium II processors, ensure that V_{CC} ramps after or with the L2 cache IO voltage (V_{CCP}). If V_{CCP} ramps after the V_{CC} , a delay circuit can be placed on the core V_{CC} to ensure that V_{CC} ramps at the same time or after V_{CCP} as shown below in Figure 1.

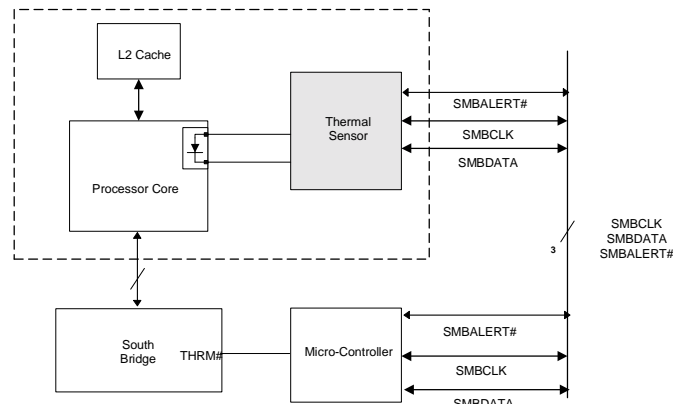
Figure 1. An Example of Microcontroller Driven Thermal Management

Problem: The Mobile Pentium II processor and the Pentium II Processor Mobile Module have a thermal sensor that monitors the processor core's temperature. Please note that desktop systems could have a similar thermal device. The thermal sensor asserts SMBALERT# if the processor temperature exceeds the temperature limits set in the Alarm Threshold Registers (T_{HIGH} , T_{LOW}). It also sets the corresponding Status Register bits to identify the cause of the interrupt. Figure 1 gives one example of the how the SMBALERT# signal could be used in a system.

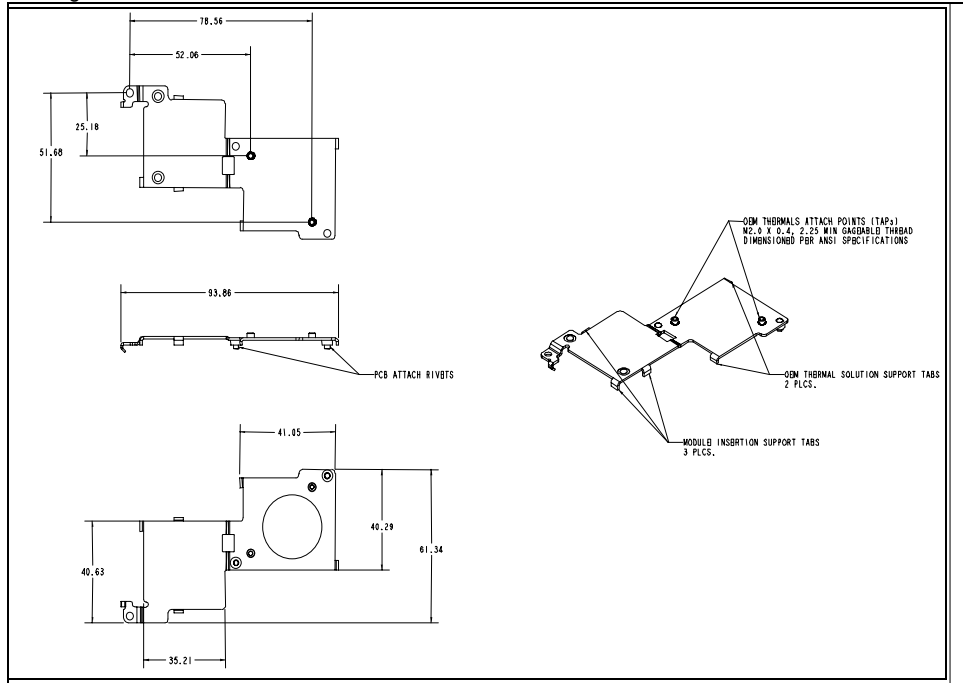
Figure 1. TAP Gageable Thread Clarification

OEM Thermal Attach Points (TAPs) M2.0 x 0.4, 2.25 min gageable thread dimensioned per ANSI specification.
